# Manhole Inspection Summary

Manhole # S21C1\_009MH

Insp Date: **5/21/08 9:05 AM**

**Location** Address: **2421 paca st**

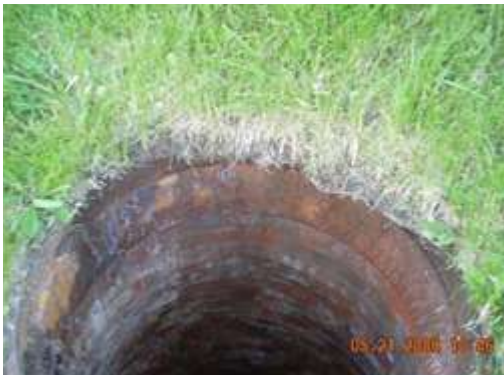
Misc. Defect 1

Subject To Ponding: **Sheeting**

inflow evidence from sheeting

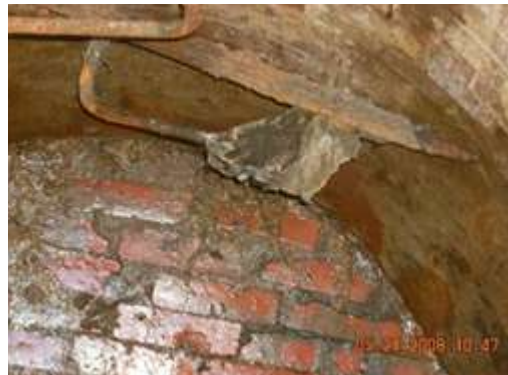
Defect 3

**Steps** Count: **4** Missing: **0** ☒ **Corroded**

**Surcharge** ☒ **Evidence Of Surcharge** Depth: **3** (ft.) ☐ Active Surcharge Present

corroded steps, surcharge evidence on bottom step

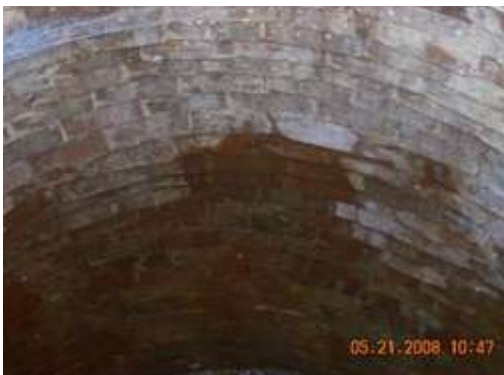
Defect 2

Infiltration: ☐ None ☐ Joint ☐ Cracks ☐ Mortar ☐ Roots ☒ **Wall**

infiltration @ barrel wall

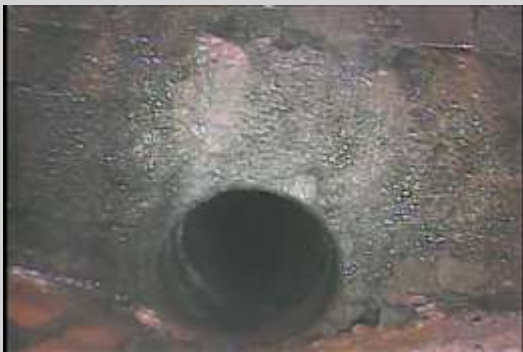
12 O'Clock Outflow

8 in. Circular Gravity Sewer  
Pipe Out @ 12 O'Clock

Pipe Height: **8.4** (in.) Rod and Bar (Angled)  
Pipe Material: **Clay** ☐ Pipe Lined  
Invert Depth: **7.90** (ft.) Flow Characteristics: **Slow**  
Deposits: ☒ None ☐ Mud ☐ **Grassy** ☐ Debris ☐ Grease  
Silt Depth: **0** (in.) Deposits Extent:  
Infiltration: **None** Pipe Seal Cond: **Unknown**

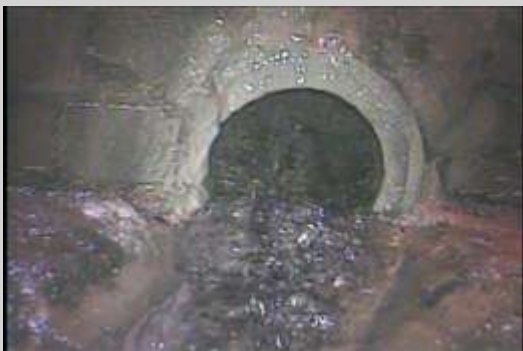
3 O'Clock Inflow

6 in. Circular Gravity Sewer  
Pipe In @ 3 O'Clock

Pipe Height: **6** (in.) Rod and Bar (Angled)  
Pipe Material: **Clay** ☐ Pipe Lined  
Invert Depth: **7.44** (ft.) Flow Characteristics: **Slow**  
Deposits: ☐ None ☐ Mud ☒ **Grassy** ☐ Debris ☐ Grease  
Silt Depth: **2** (in.) Deposits Extent: **Medium**  
Infiltration: **Evidence** Pipe Seal Cond: **Cracked**
